Re: Your BPL Complaint

Cottonwood Arizona, and BPL

Re: Experimental Station WB9XVP (File No. 0136-EX-ST-2004)
At Cottonwood (Yavapai County) Arizona; Broadband Over Power
Line System; Evaluation and Critique of 6-Month STA Report.

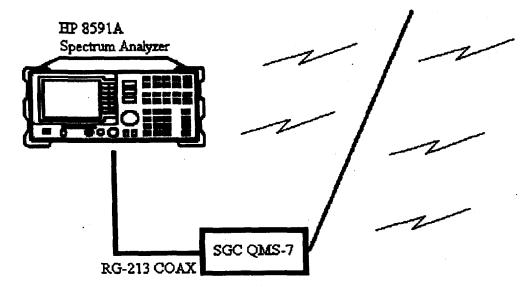
(Figure 1. Test setup)

Above is a block diagram showing the test configuration used for measuring the BPL signals. The QMS-7 with the 7-foot whip antenna was mounted on the lift gate of a 1996 Jeep Cherokee. The RG-213 was attached to the spectrum analyzer with a SO-239 to N male adaptor, as the instrument has an N female jack on the front.

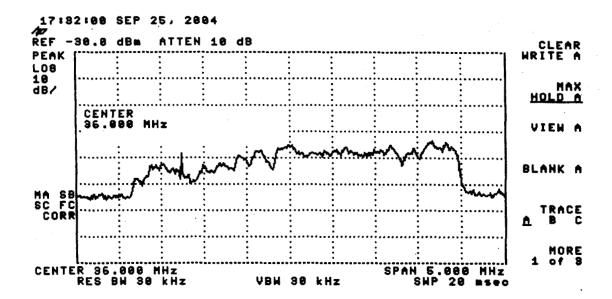
(Plot 1)
A sample of HF spectrum around 36Mhz, the width of the span is 5Mhz; each division is 0.5MHz. The range of the plot is from 33.5Mhz to 38.5Mhz, there are no HF amateur bands in this portion of the spectrum. The signal is on average S9+ on an HF receiver.

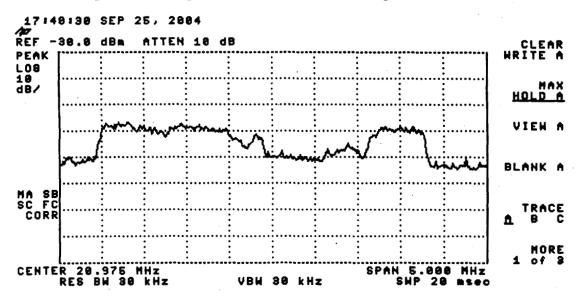
(Plot 2)
This plot shows a second set of carriers, 18Mhz and 22Mhz at -60dBm. The 4th vertical column from the far right is the amateur 15-meter band (21.100MHz to 21.450MHz). The signals represent S9+10dB on an HF receiver.

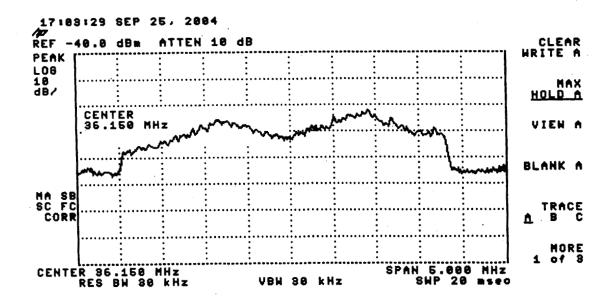
(Plot 3)
The signal looks like two broadband carriers positioned side-by-side in the spectrum.
These carriers are not within amateur radio allocation, but again sampled to learn the effects of BPL. When monitored with a HF receiver the signal strength would exceed S9+10dB.

To determine the field strength of the measured signals on the spectrum analyzer, the frequency and amplitude must both be known. Looking on plot #3 from American Heritage Academy, it shows a point around 35MHz that is approximately -65dBm.

-65dBm + 107dB + 12.3dB (Antenna Factor at 35MHz) = $54.3dB\mu V/m$

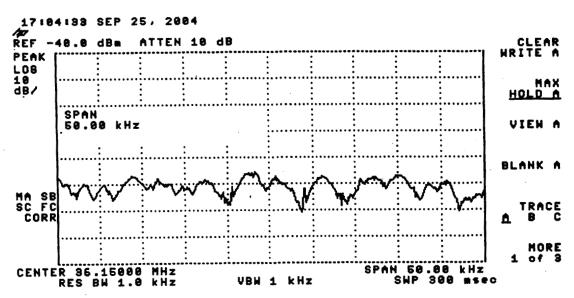
(Plot 4)
Span zoomed to show individual carriers randomly spaced near 5KHz from each other.
As the ICOM R-10 receiver was tuned anywhere between 34.150MHz and 37.900MHz a tone with a cyclic clicking was heard on the receiver in the following modes: CW-N, USB, and LSB.

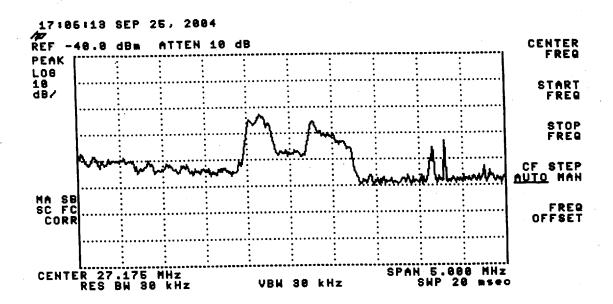
(Plot 5)
These carriers were also noticed, and are in the Citizens Band portion of the HF spectrum. While watching the site in a broader span, these carriers along with the carriers present at 36MHz came up and down together.

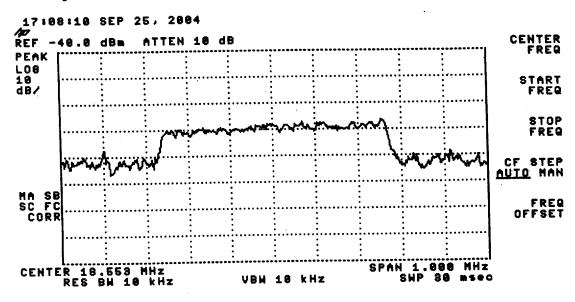
(Plot 6)
This carrier is centered on 18.55MHz, but with a bandwidth of 600KHz, it does approach the 17-meter band (18.068MHz to 18.168MHz) at a level equal to S9+ on an HF receiver.

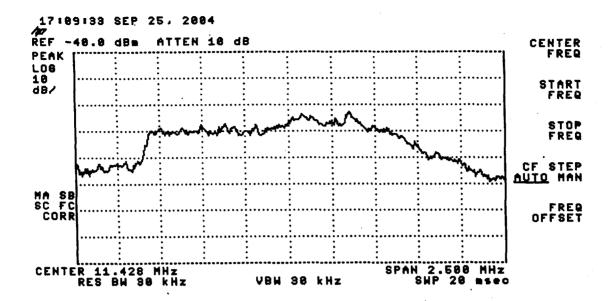
(Plot 7)
This carrier is also out of the amateur radio bands, but is close enough to interfere with 10MHz WWV reception. I was able to receive 10MHz WWV when this site was atleast ¼ mile away. As I approached this BPL test site, the noise floor captured the receiver. This carrier also hampers the ability for amateur radio operators to use the 30-meter band (10.100MHz to 10.150MHz) with a reading approaching S9+ on an HF receiver.

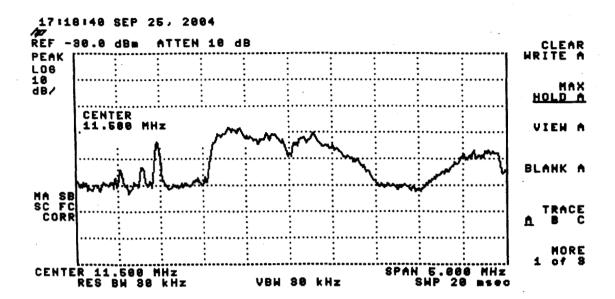
(Plot 8)
The carriers centered around 11.5MHz are strong enough to interfere with 30-meter (10.100MHz to 10.150MHz) operations. WWV on 10MHz was difficult to receive.

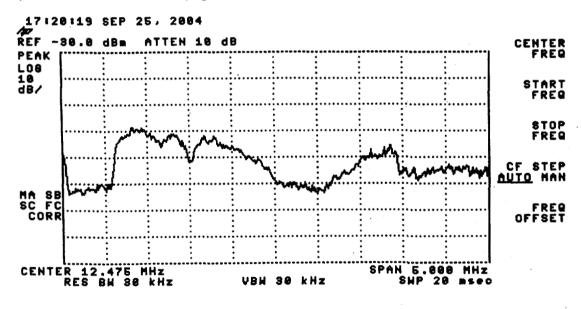
(Plot 9)
Additional carriers from the same BPL test site are present around 12.5MHz. This is strong enough to eliminate any ability to receive short wave broadcast services.
